Manhole Inspection Summary

Manhole # S29II2004MH

Location Address: **4 GITTINGS AVE**

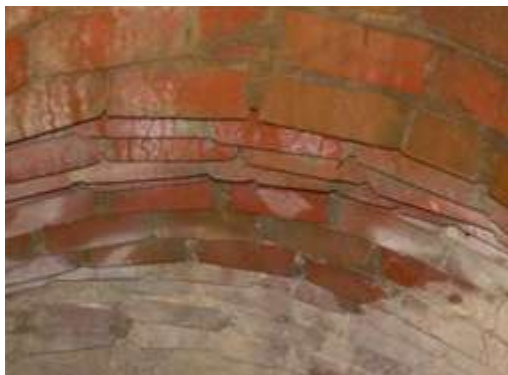
Defect

Channel debris. Barrel infiltration.

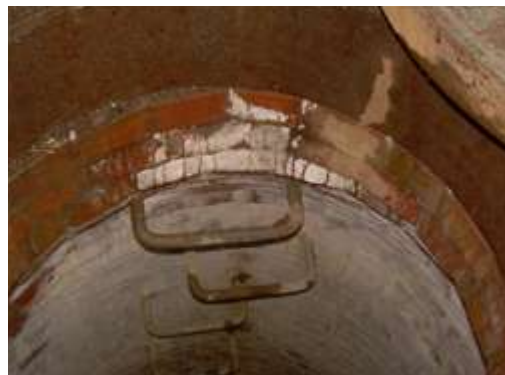
Defect

Adjustment and Corbel infiltration - other side.

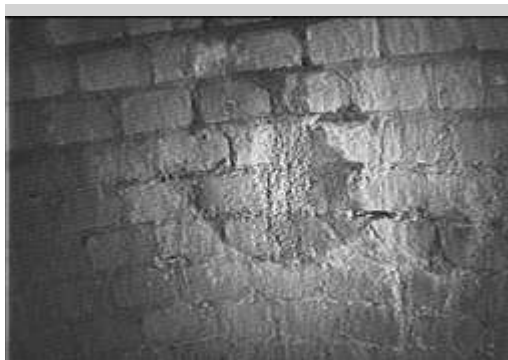
Defect

Frame leaks. Adjustment and Corbel infiltration.

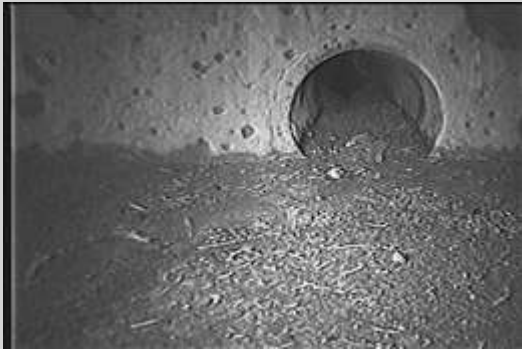
8 in. Circular Gravity Sewer
Pipe Out @ 12 O'Clock

Deposits: ☐ None ☒ **Mud** ☐ Sludge ☒ **Debris** ☐ Grease

Infiltration: **Evidence** Pipe Seal Cond: **Unknown**
